PRESS RELEASE

Façades can significantly affect the spread of fire

The large scale fire test: completely identical samples at first sight

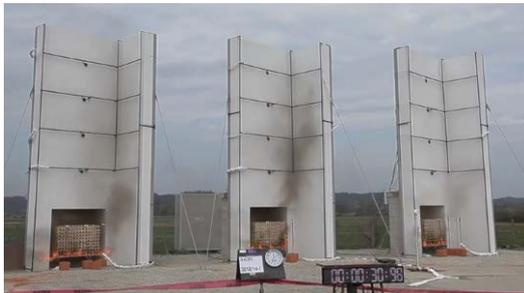
The façade systems from left to right:

Sample 1 classified system with combustible isolation (EPS), B s2 d0, **sample 2** classified system with combustible isolation (EPS), B s2 d0 + 20 cm horizontal fire barrier made of stone wool and **sample 3** classified system with non-combustible insulation (stone wool), A2 s1 d0. All other components are identical in all three samples.

The photo shows the very beginning of the test (0:30) when the furnaces that simulate an apartment fire are lit, all at the same time. A few minutes later fire is coming out of the window.

All three samples were identical apart from only one important component: the type of thermal insulation material. All of them were covered with classified façade systems; one with combustible insulation (EPS), B s2 d0, another one with combustible insulation (EPS), B s2 d0 + stone wool horizontal fire barrier, while the third one with non-combustible insulation (stone wool), A2 s1 d0. All were lit at the same time.

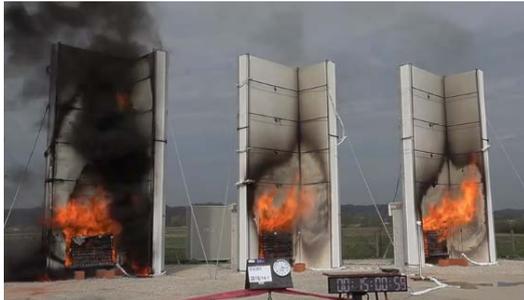
15 minutes after the start of a fire:

Sample 1 is completely caught by fire while it emits large quantities of toxic smoke and gases. Flaming droplets of the burning insulation are increasing the area affected by fire

At this point there is no greater difference between the reactions of the **sample 2** and **sample 3**

During the test, the sample with EPS insulation completely burned and the fire spread across the façade throughout the wall only 15 minutes after the outbreak. Also, the guests could see large amounts of toxic black smoke resulting from the combustion of flammable materials. The fire on the 3rd sample did not spread across the façade due to non-combustible insulation (stone wool) and the wall structure remained undamaged. Miodrag Drakulić, President of HUZOP commented: *“Fire barrier made of non-combustible materials between floors should function as horizontal fire protective barriers. We saw today that relatively small barrier can slowdown the fire spread on the facade but it cannot effectively stop the spread of fire. As seen on the 2nd sample, it did delay the spread of fire for about 10 minutes compared with the system made entirely of EPS, but for longer prolongation of fire spread alongside combustible façades, fire protective barriers have to be designed according to proven technical rules. But, in spite of these prevention measures for fire spread, risk of toxic gases emitted from combustible façades is still very high. And we should remember that statistics show that 8 out of the 10 people killed in the fire actually die due to poisoning with toxic gases, not because of fire”.*

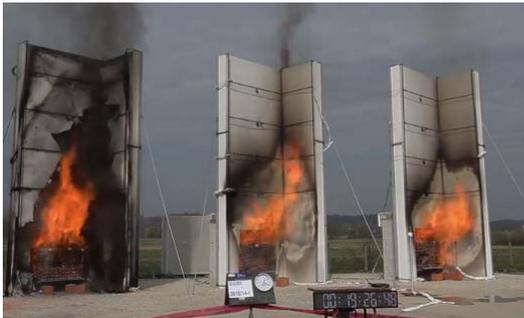
19 minutes after the start of a fire:

Sample 1 is still emitting large quantities of toxic smoke and gases.

On **sample 2** the fire jumped over the fire barrier placed above the window frame and caught the combustible insulation (EPS). The evidence is black smoke at the top of the wall.
On **sample 3** the fire has not caught the insulation.

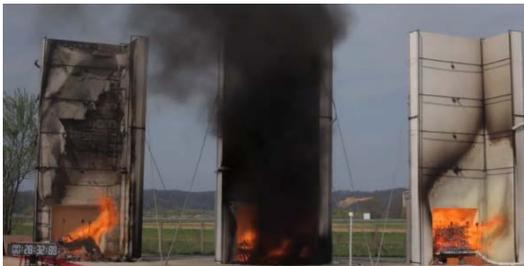
28 minutes after the start of a fire:

Sample 1 the system has burned out. The steel frame with sensors prevent parts of final decorative plaster from falling.

On **sample 2** the fire spread entirely on the combustible insulation which now emits large quantities of toxic smoke. The situation on the **sample 3** is unchanged.

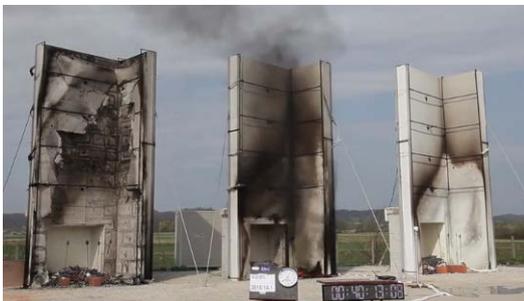
40 minutes after the start of a fire:

Sample 2 is still burning and emitting toxic smoke, even though the fire is not visible. The horizontal stone wool fire barrier above the window frame has delayed escalation of fire for about 10 minutes, but also extended the time of burning of the insulation and emission of toxic gases. The fire in the furnace of **sample 3** extinguished on its own. Unlike **samples 1** and **2**, the façade on the third sample is not structurally damaged.

These photos were taken during the preliminary test on March 28th, 2014 on identical samples as the ones used for public test on May 28th 2014.
